Closed-Loop/Water Reuse System for a Large Wire Extrusion Facility

Timothy St. Germain, P.E. April 18, 2006

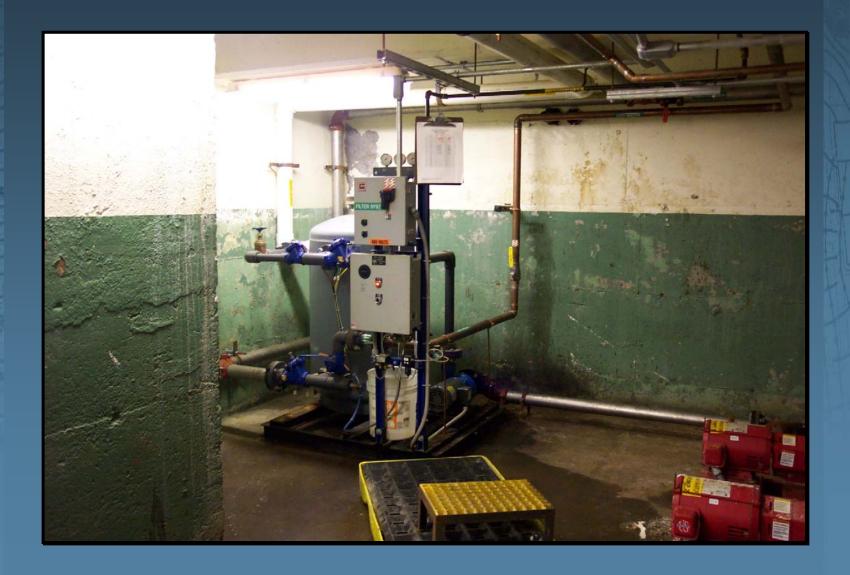
Side Stream Filter

- Chlorinated municipal feed
- Algaecide/corrosion inhibitor in process
- Multi-media filtration and system backwash to sanitary sewer
